**BOREHOLE GEOPHYSICAL LOGGING
CABO ROJO GROUNDWATER CONTAMINATION SITE
CABO ROJO, PUERTO RICO**

File 13RG03
November, 2013

RE: Borehole Geophysical Logging
Cabo Rojo Groundwater Contamination Site
Cabo Rojo, Puerto Rico

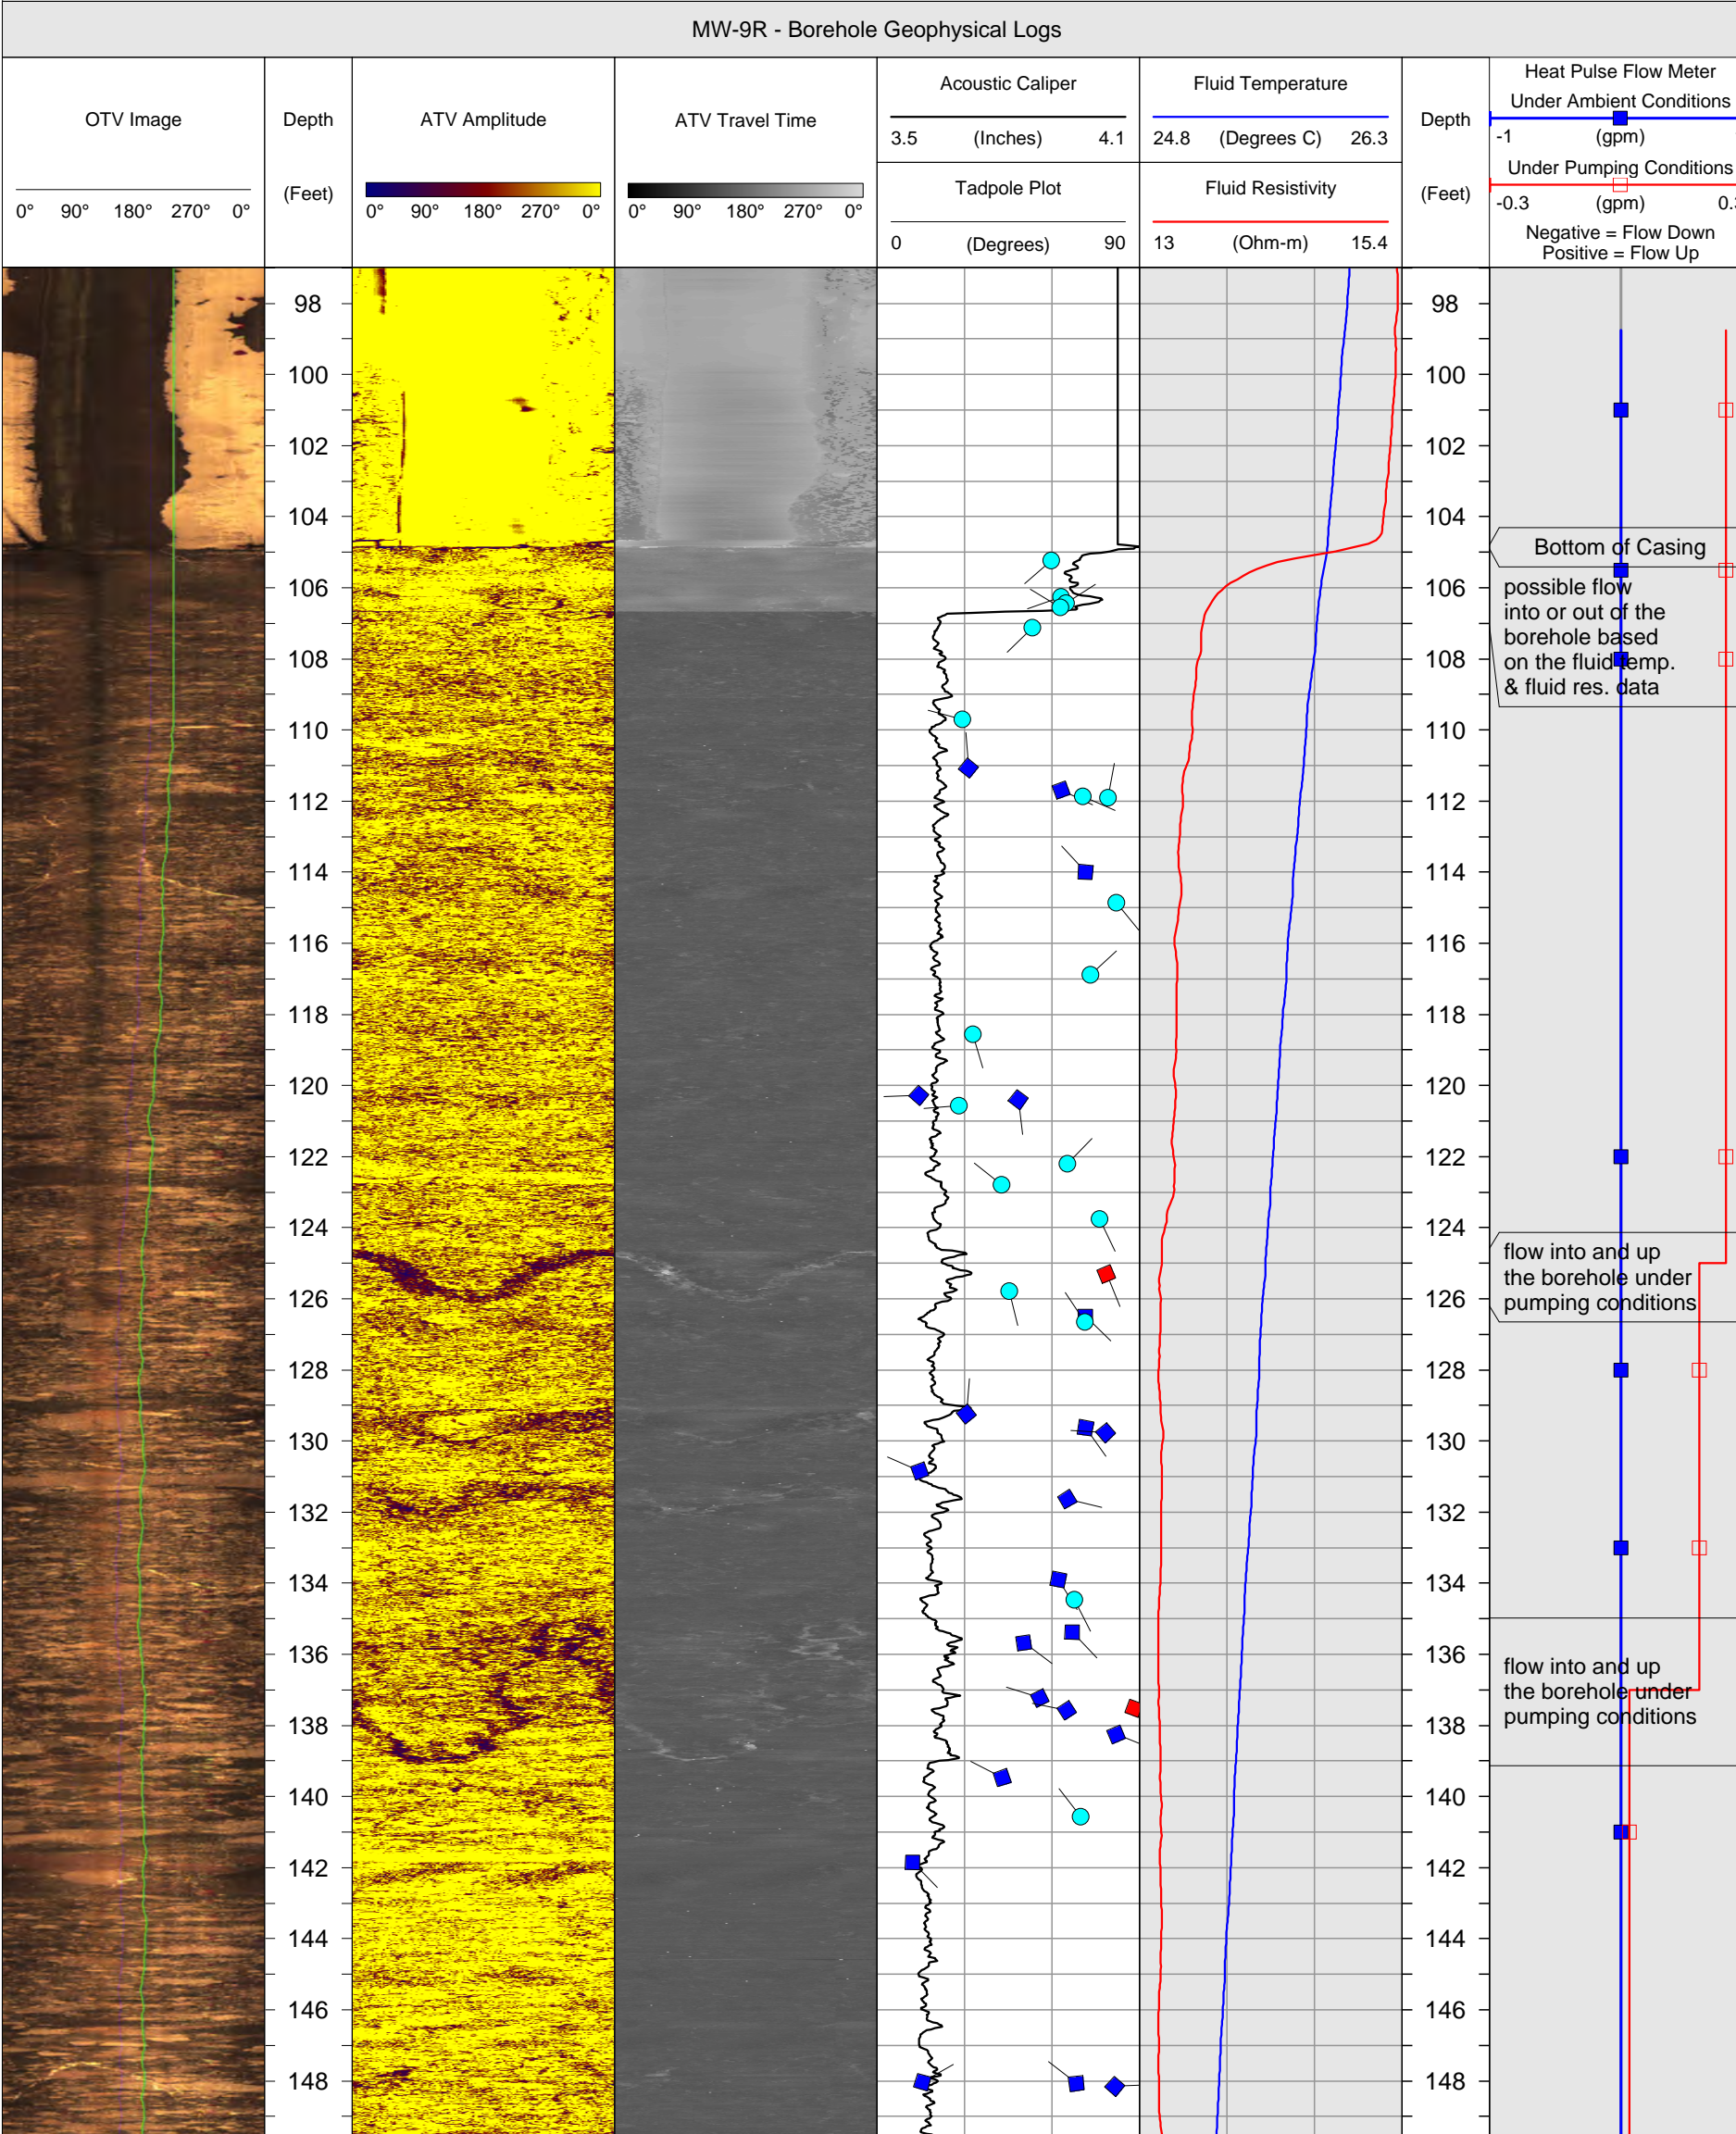
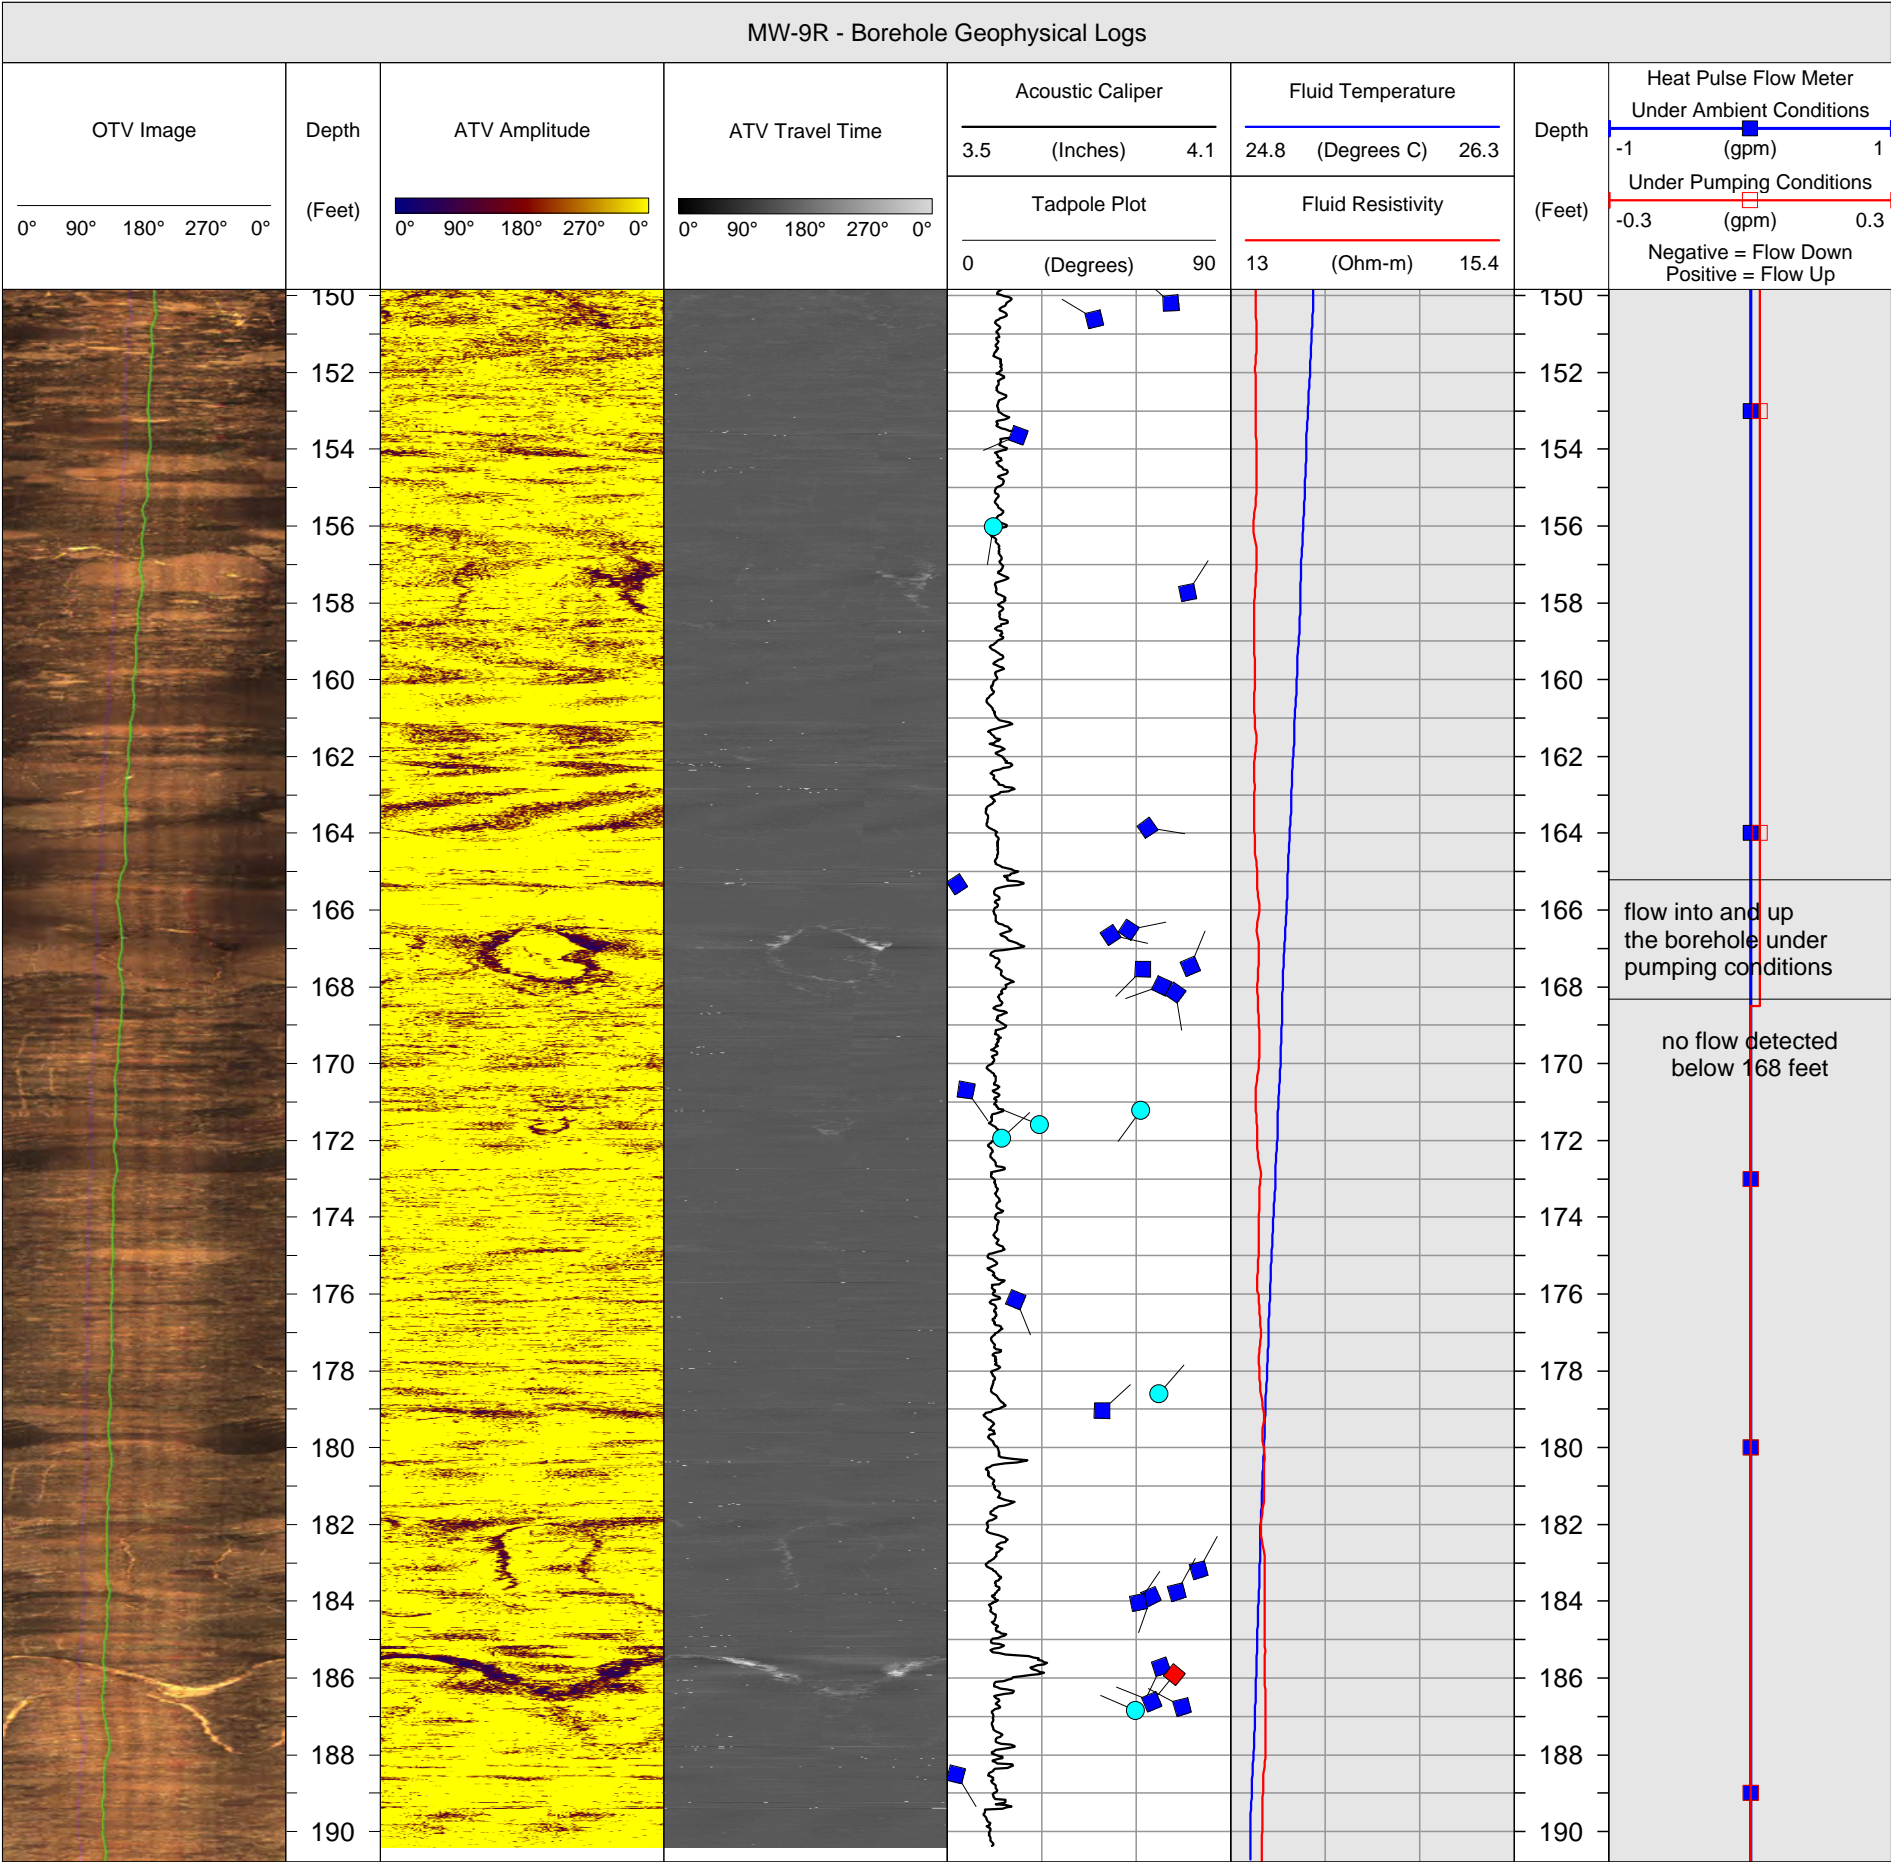
Flow was not detected in borehole MW-9R with the HPFM under ambient conditions. Therefore, flow results in this report for MW-9R are based only on the HPFM data under pumping conditions as well as the fluid temperature and fluid resistivity data.

NOTES: Flow was not detected in MW-9R with the heat pulse flow meter under ambient conditions.

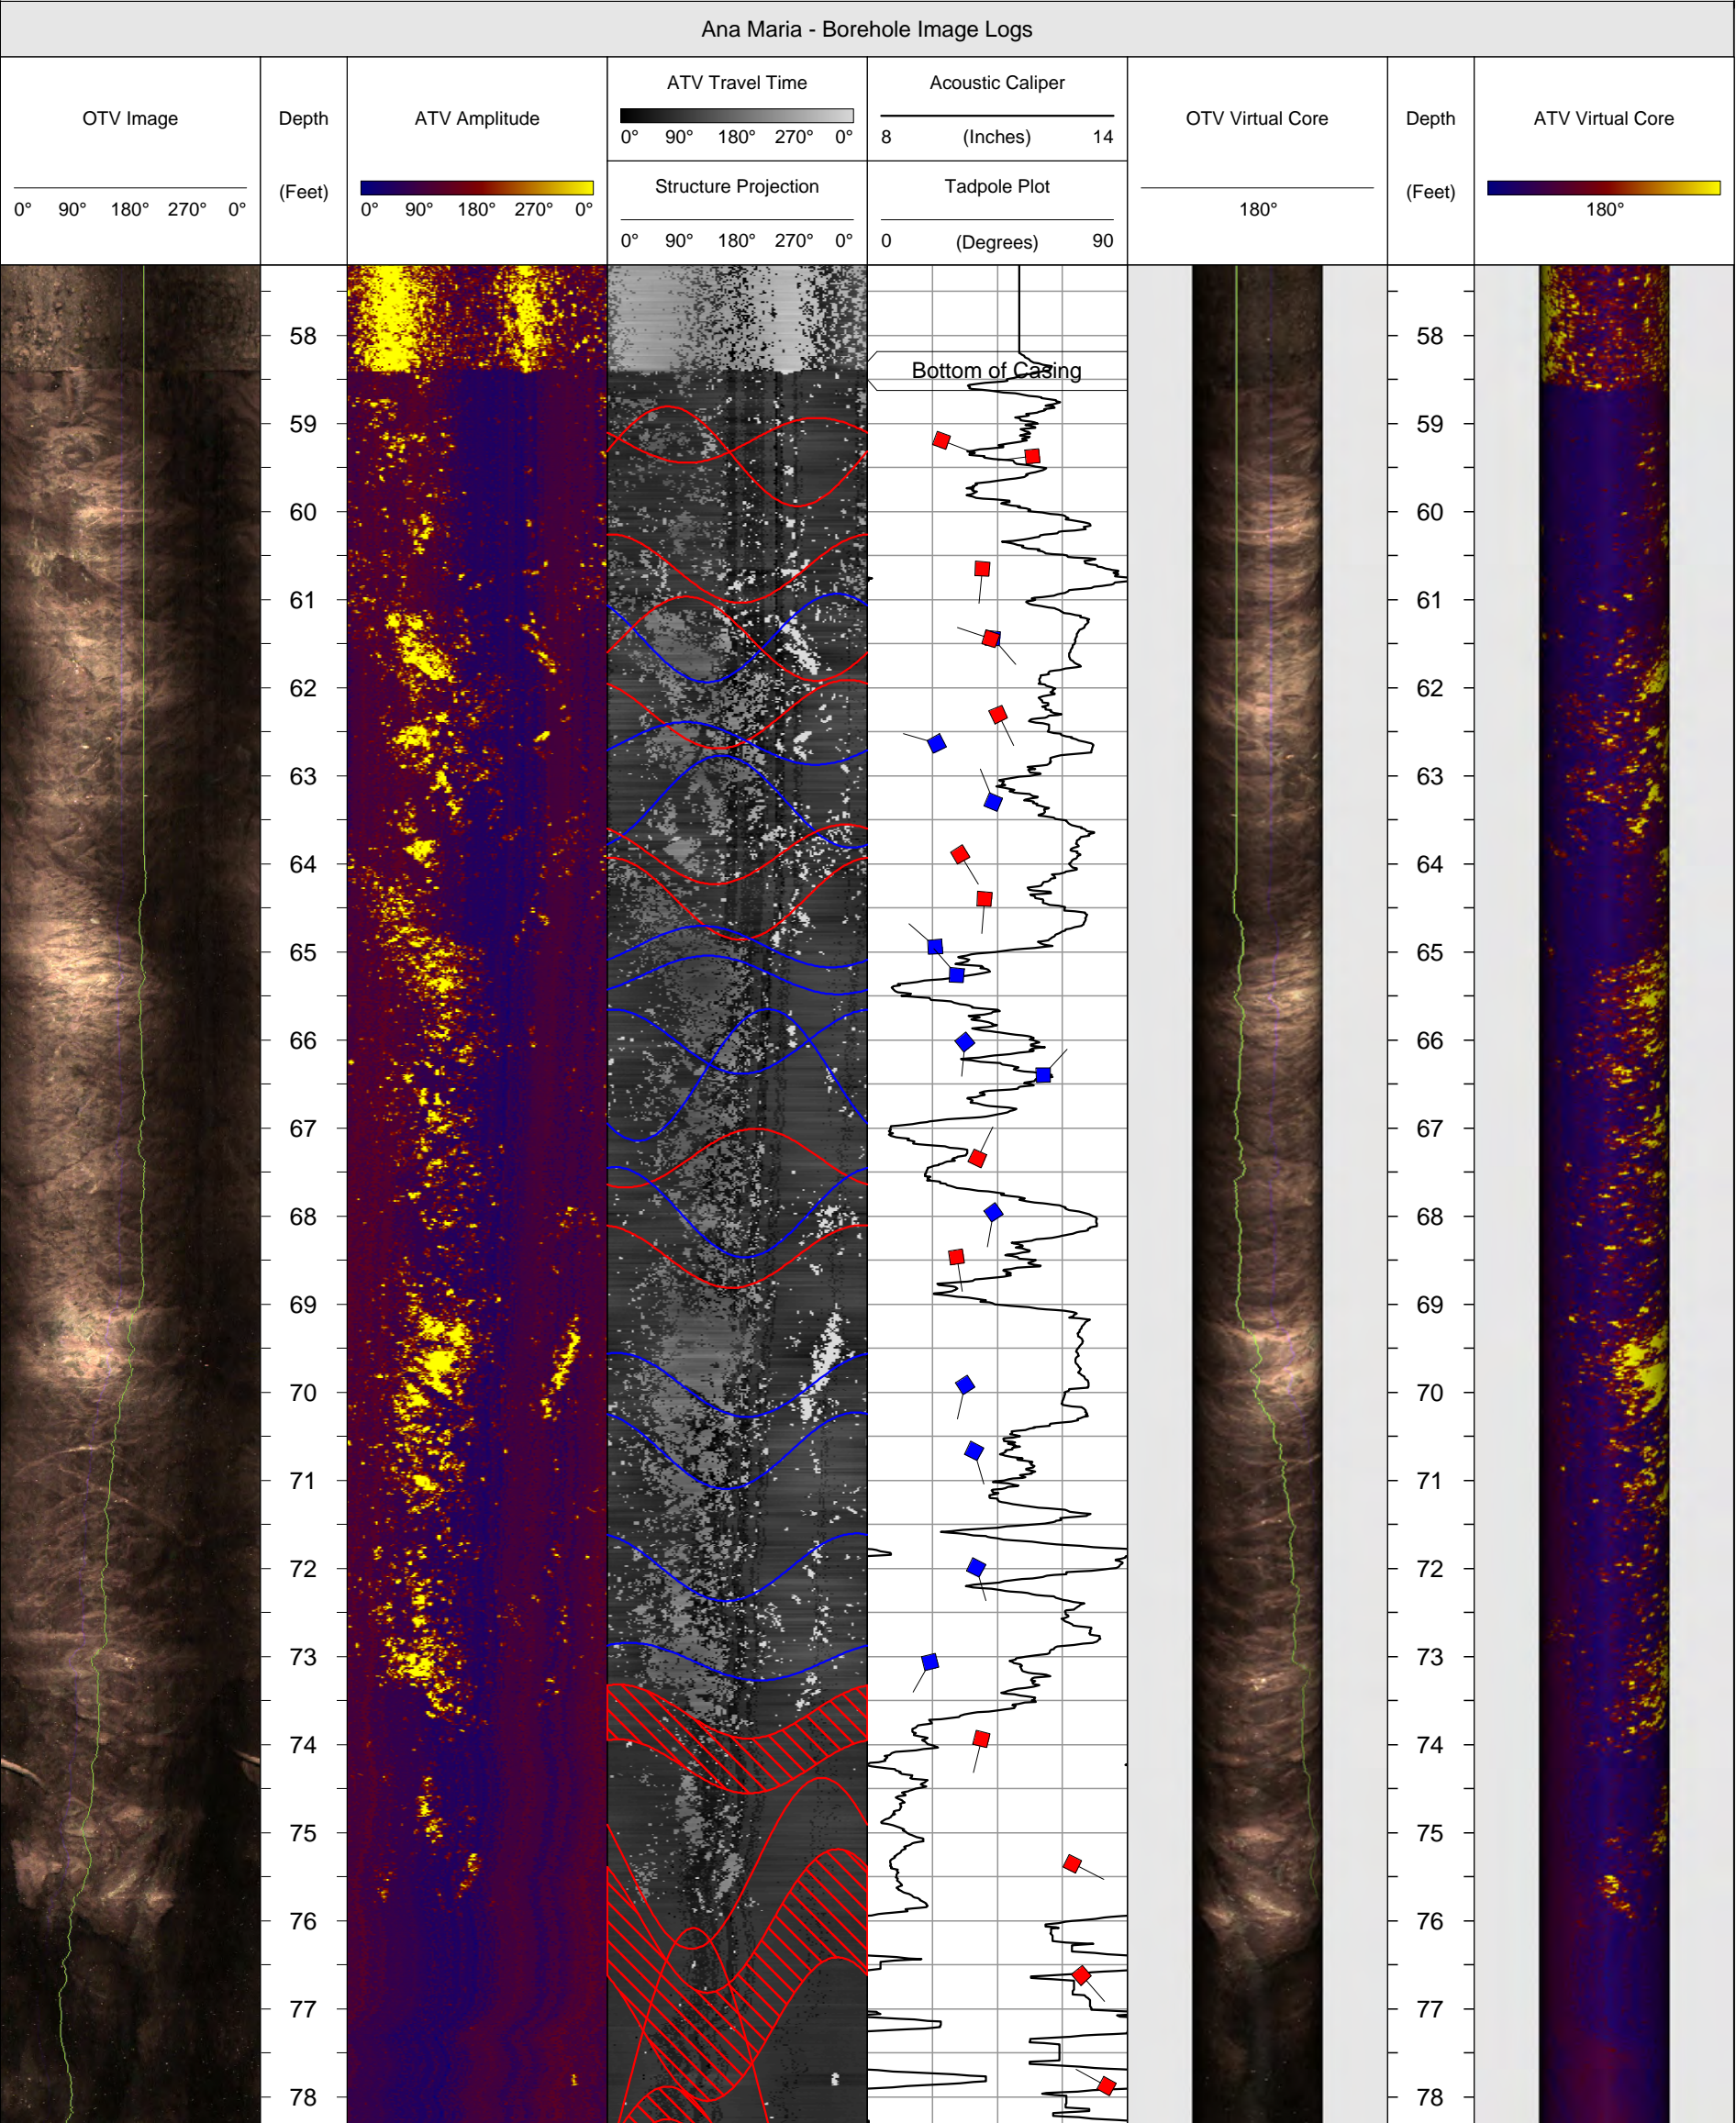
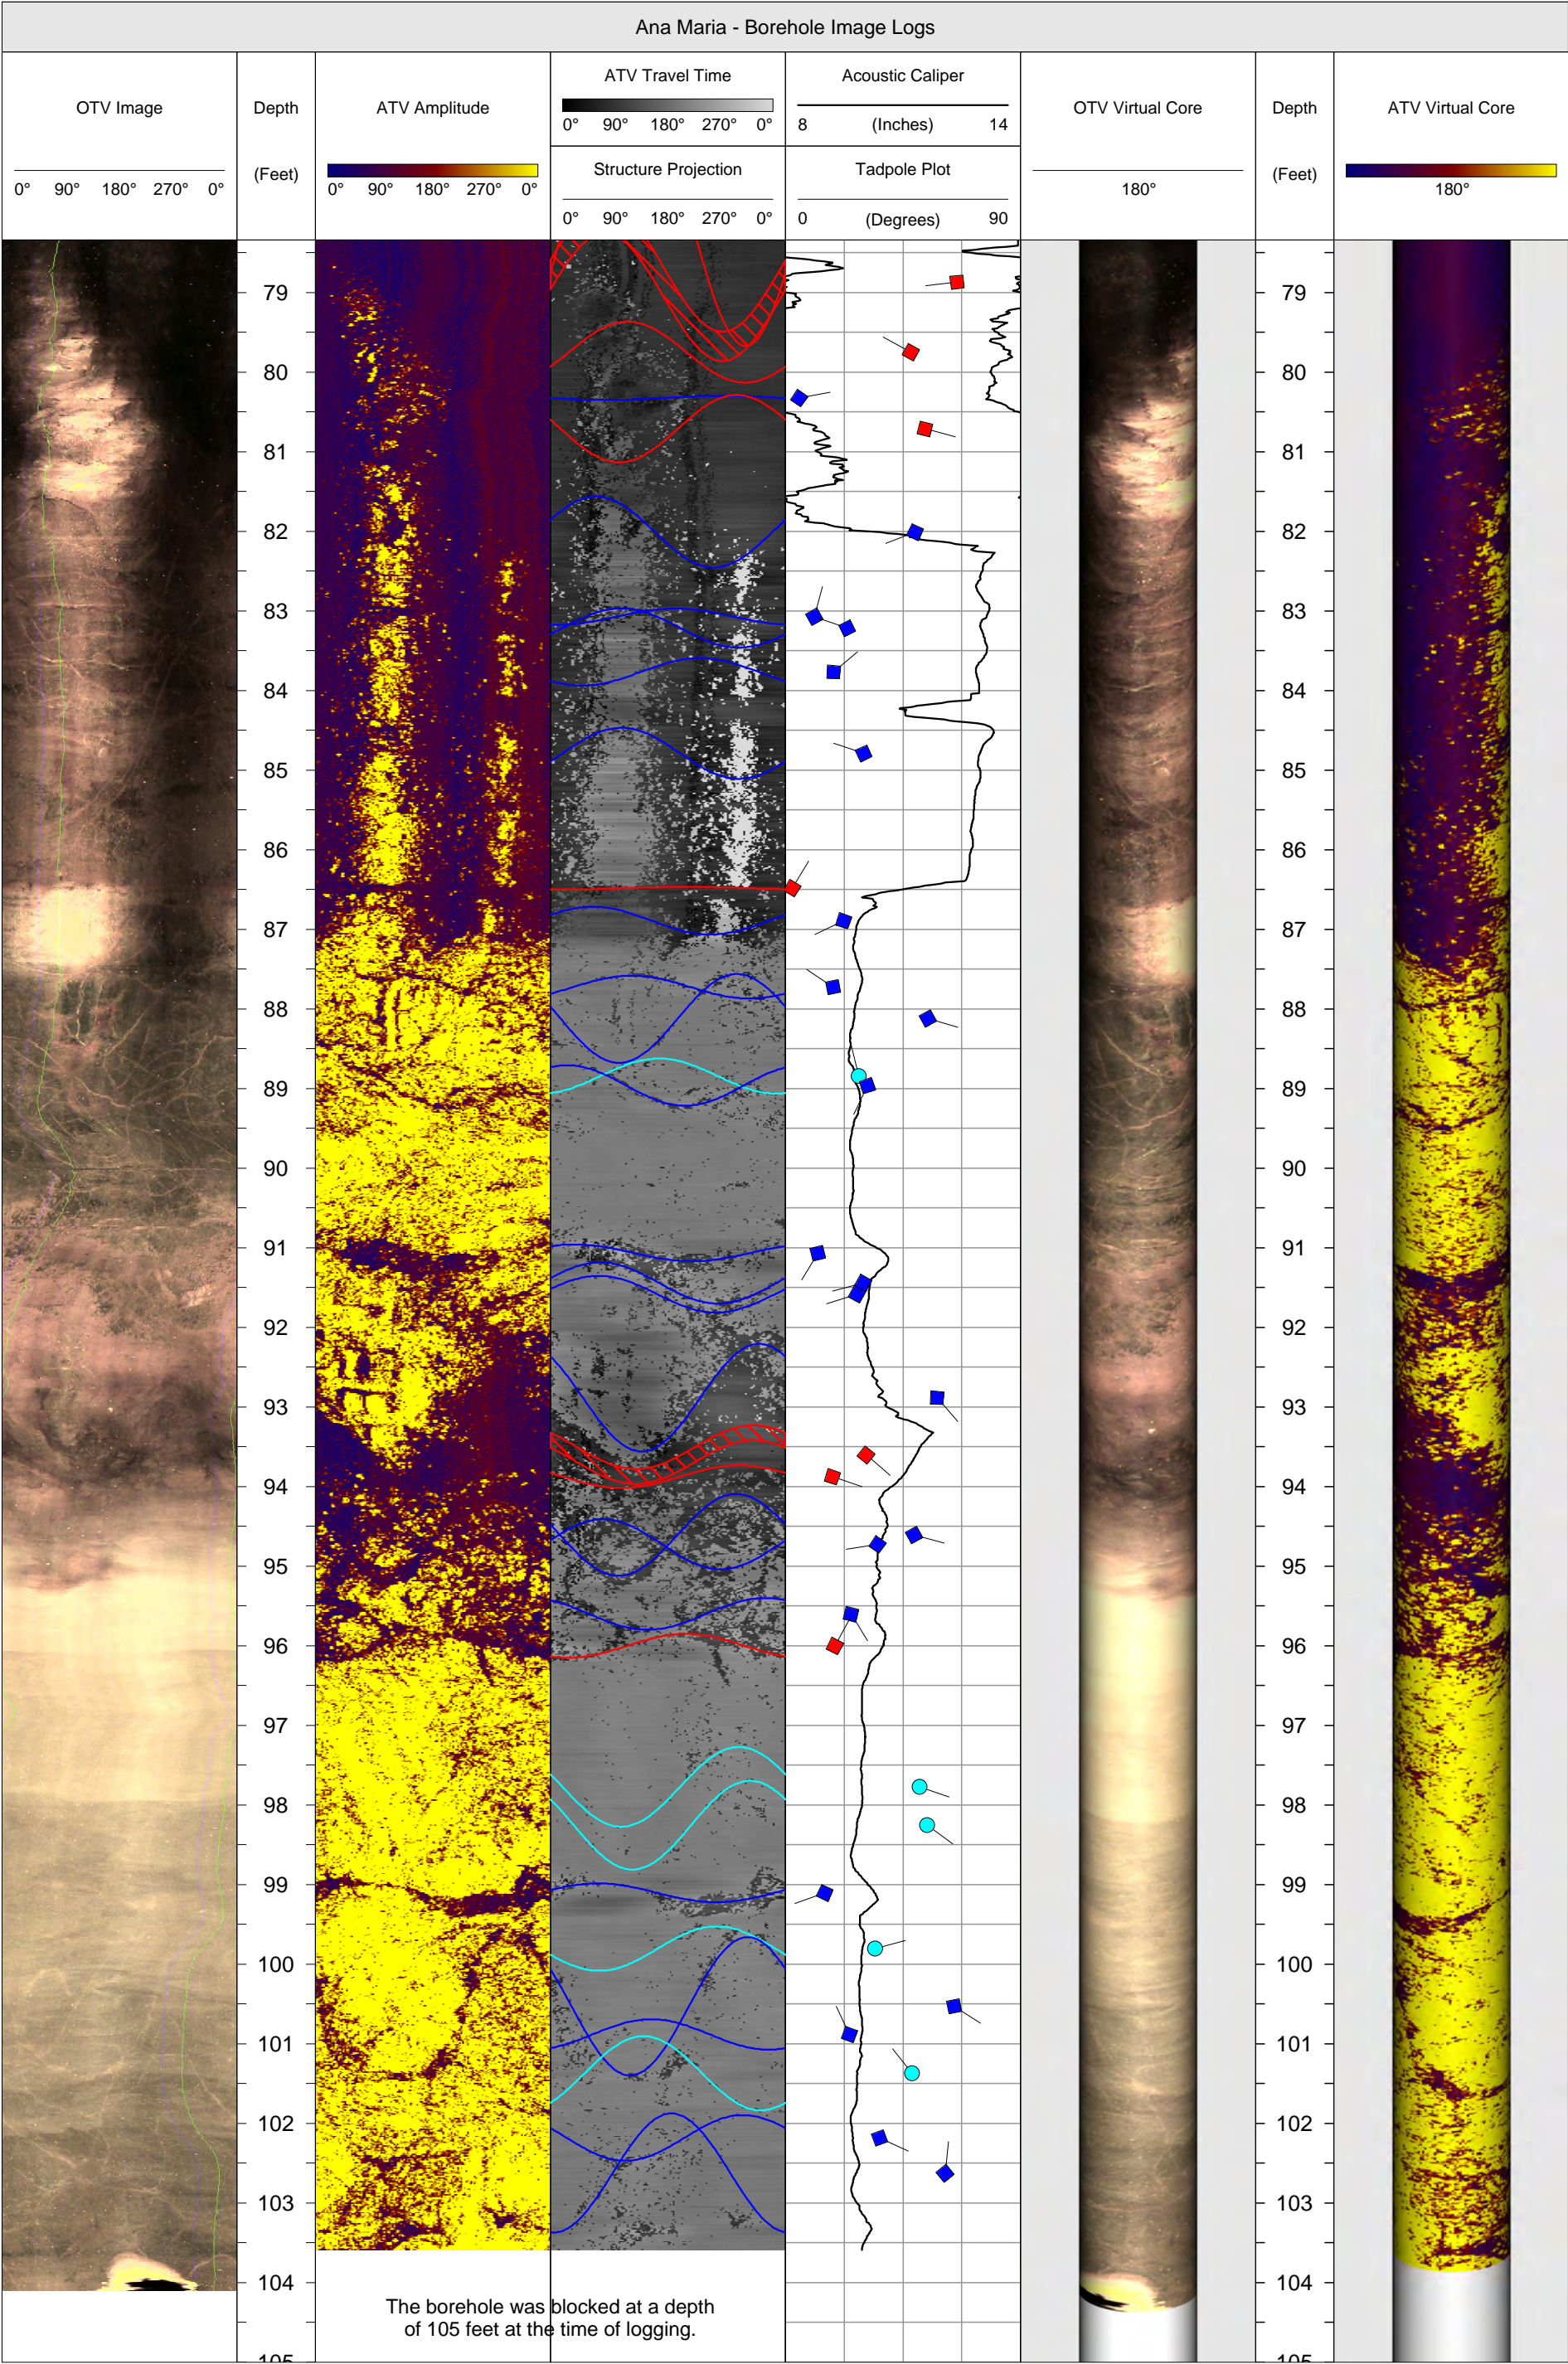
Highly fractured and weathered bedrock was evident in Ana Maria from the bottom of casing at 58.4 feet to approximately 87 feet and in Pozo Escuela from the bottom of casing at 39.0 feet to approximately 58 feet. These highly fractured and weathered shallow bedrock zones caused irregularly shaped boreholes and sharp changes in borehole diameter. These conditions made it difficult to centralize the televiewer probes and to identify individual fractures within these highly fractured zones.

The highly fractured and weathered shallow bedrock in Ana Maria and Pozo Escuela are both interpreted as hydraulically transmissive zones based on the HPFM results. It was not possible to determine individual flow pathways within each of these fracture zones as the fractures in each of these zones are interconnected and acting as a single hydraulic unit.

105.0	the borehole was blocked at a depth of 105 feet at the time of logging; flow into and up the borehole from within or below the blockage under ambient and pumping conditions

NOTES: The borehole was blocked at a depth of 105 feet at the time of logging.

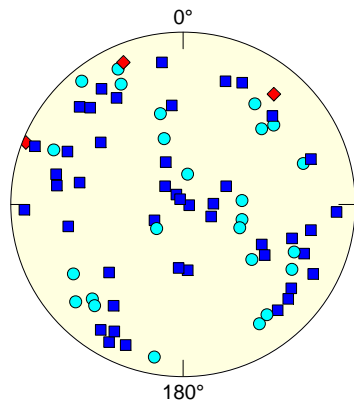
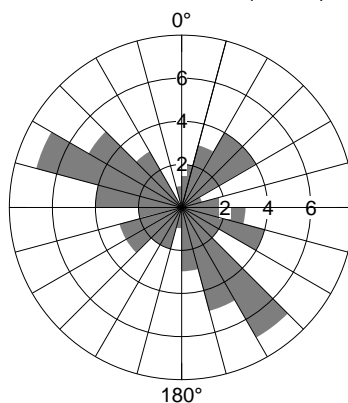
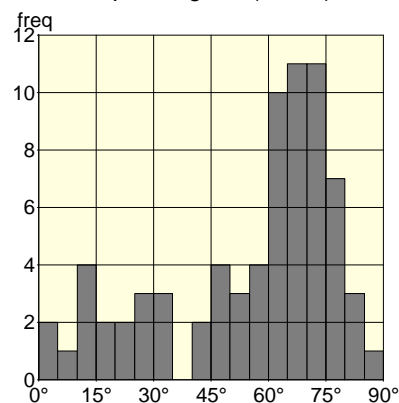
MW-9R - FRACTURE STATISTICS PLOTS

Counts	Dip[deg]	Azi[deg]
Mean	73	55.71	189.62
●	25	55.78	264.77
■	45	54.00	118.56
◆	3	79.67	161.67

Counts:	73.00
Mean:	189.62
Std.Dev.:	142.68
Min:	4.52
Max:	355.62

Counts:	73.00
Mean:	55.71
Std.Dev.:	22.38
Min:	2.93
Max:	87.98

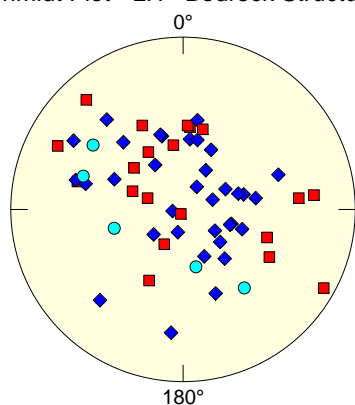
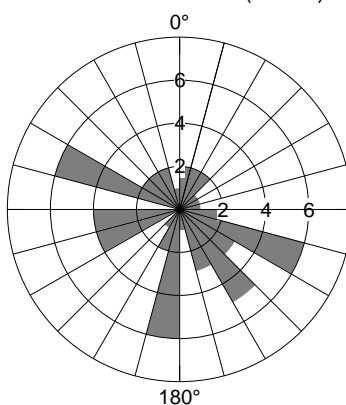
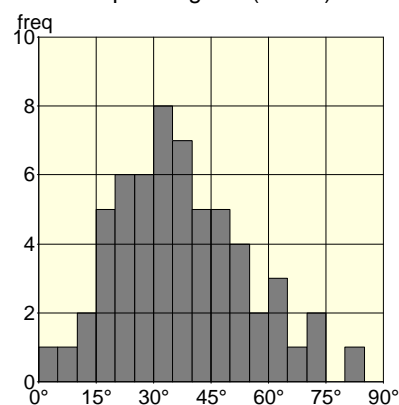
ANA MARIA - FRACTURE STATISTICS PLOTS

Counts	Dip[deg]	Azi[deg]
Mean	59	37.39	180.39
■	20	42.80	150.93
◆	34	33.39	223.40
●	5	43.34	59.07

Counts:	59.00
Mean:	180.39
Std.Dev.:	112.85
Min:	5.59
Max:	347.24

Counts:	59.00
Mean:	37.39
Std.Dev.:	17.13
Min:	2.68
Max:	82.78

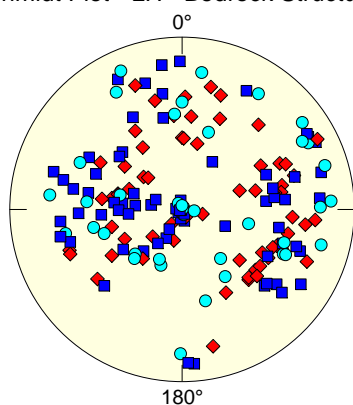
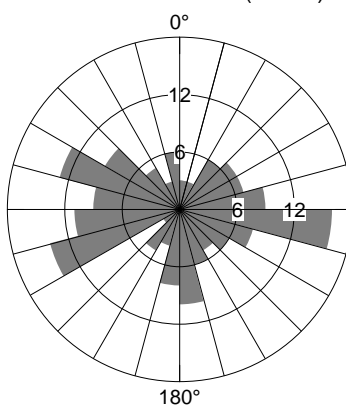
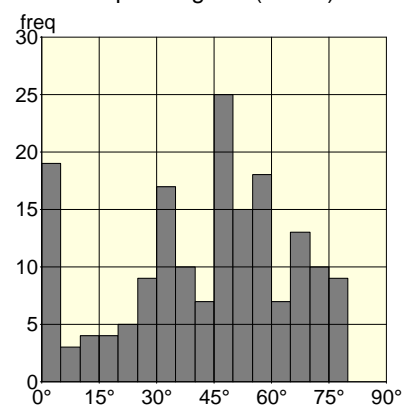
POZO ESCUELA - FRACTURE STATISTICS PLOTS

Counts	Dip[deg]	Azi[deg]
Mean	175	43.05	198.78
◆	62	43.74	243.41
■	72	41.86	90.24
●	41	44.03	224.29

Counts:	175.00
Mean:	198.78
Std.Dev.:	138.35
Min:	0.87
Max:	358.53

Counts:	175.00
Mean:	43.05
Std.Dev.:	21.91
Min:	0.57
Max:	78.91
